Highland Park Dam Mitigation Project

FINAL REPORT

CITY OF TOLEDO in LUCAS COUNTY, OHIO

February 2009

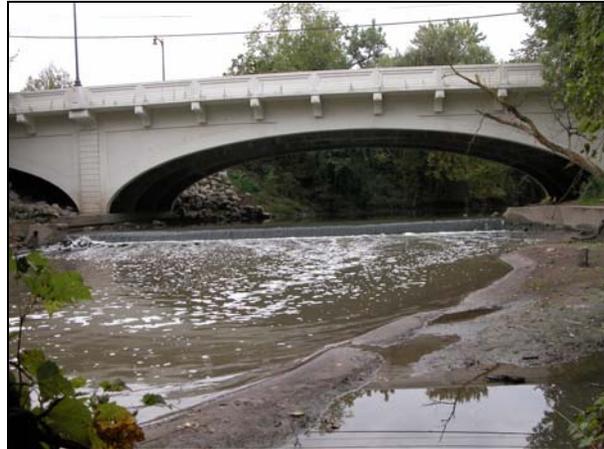
Highland Park Dam looking upstream before construction.

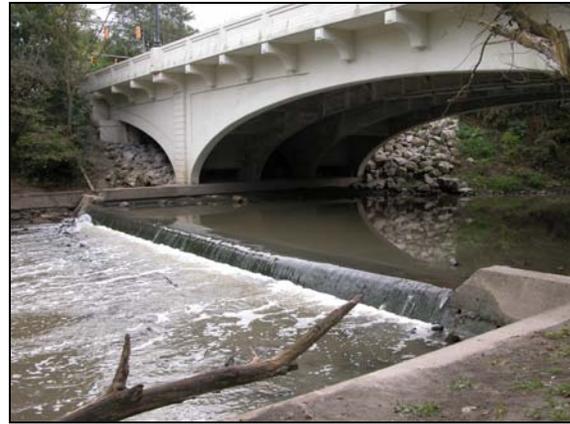
Highland Park Dam before construction.

Water flowing over the dam created a scour hole immediately downstream of the dam. The combination of the dam height and the scour hole created a barrier to fish passage with a 3 to 4 feet drop in water surface during low stream flow conditions.

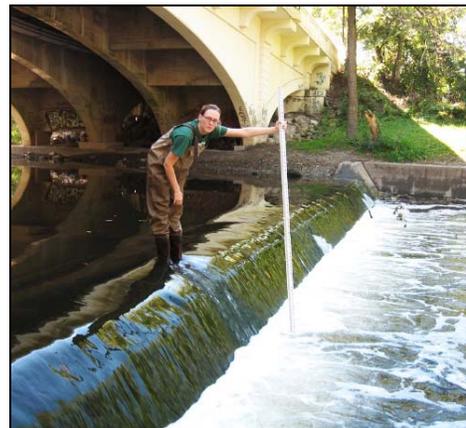
JFNew conducting an on-site survey during the fall of 2007.

JFNew performed an in-stream cross-section and longitudinal profile survey of about 2,400 feet of Swan Creek in November 2007. The surveyed reach was between the South Avenue Bridge and the Champion Street Bridge. The first cross-section was taken on the upstream side of the South Avenue Bridge (about 50 feet upstream of the dam), and the last cross-section was taken just upstream of the Champion Street Bridge. Cross-sections were spaced approximately 100 to 200 feet apart, with closer spacing between cross-sections at the dam. Cross-sections were taken just upstream and downstream of each of the bridges (including the Highland Park footbridge).

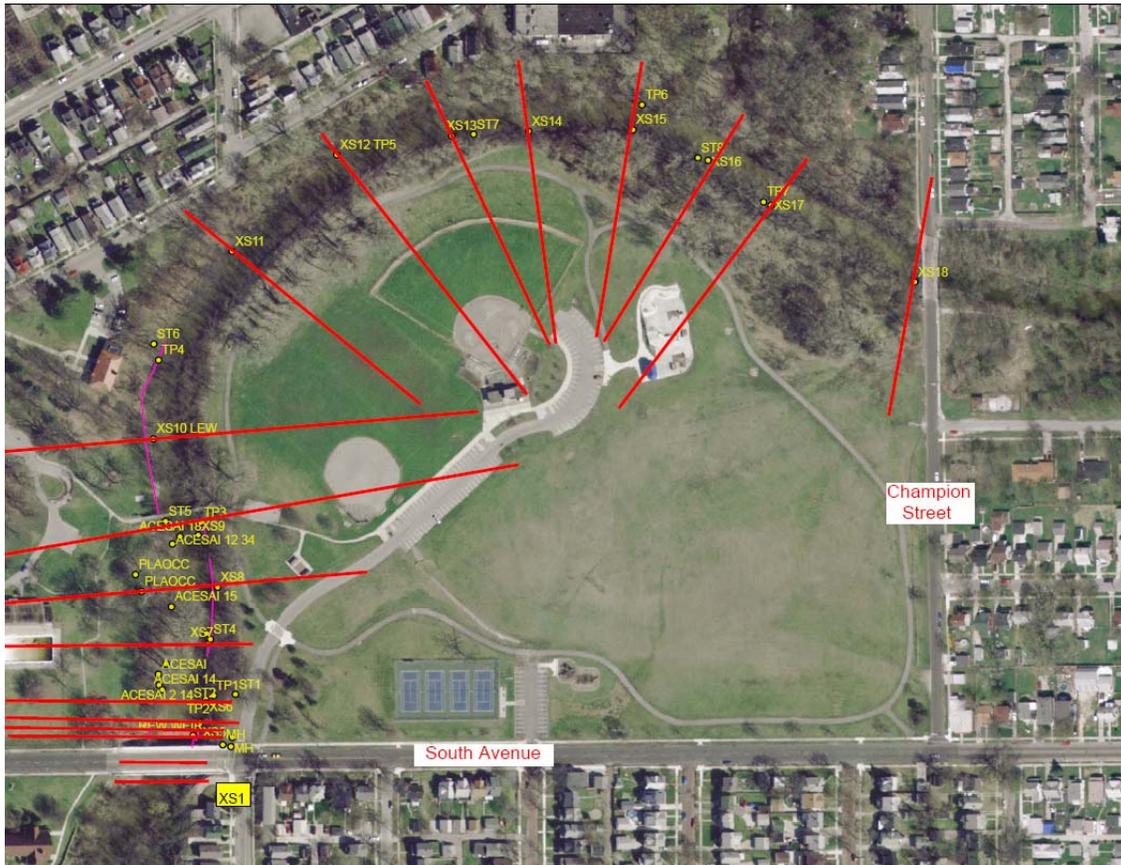
Surveyed cross-section locations on Swan Creek at Highland Park.

We compiled dimensions of the bridges from field measurements and drawings obtained from the City of Toledo. Although in-stream work was not planned in the downstream portion of the surveyed reach, we included these cross-sections because the Lucas County Flood Insurance Study (FIS) indicates that the Champion Street Bridge plays a role in controlling flood elevations upstream. The survey cross-section locations are shown below.

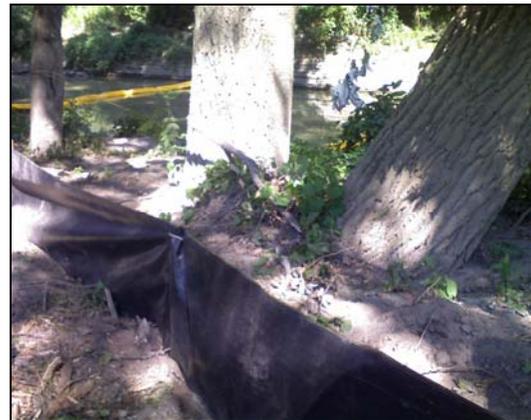
Silt fences (black in foreground) were installed on land and silt curtains (yellow in background) in the water to control sediment leaving the construction site.

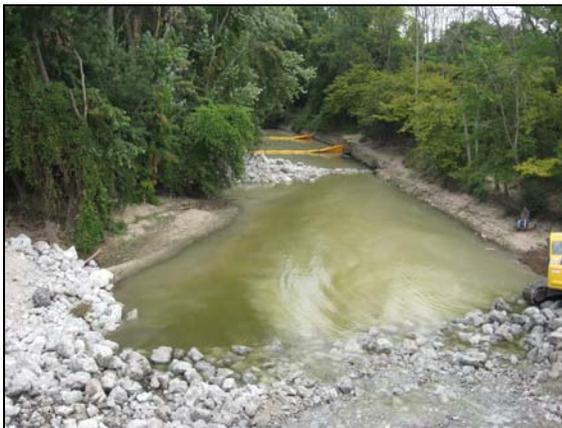
Silt curtains were installed downstream of the second structure.

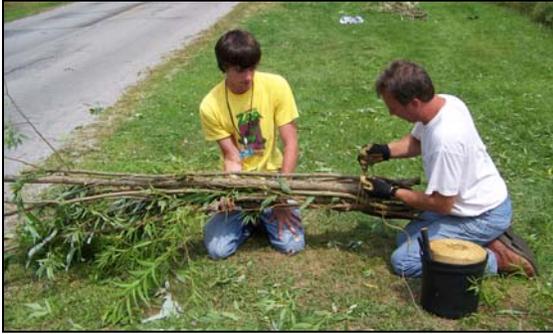
Matt Horvat bundles live stakes with Toledo ZooTeen assistance.

When harvesting at each site, the live stakes were cut at the base and hauled to an open area for “processing”. Once in the open area the stakes had most of their leaves and any small branches removed with hand pruners. They were cut to a length of approximately 5-7 feet long and placed in bundles of approximately 25-35 stakes. Trimming and cutting to length meets two needs. The stakes are easier to handle when bundling, transporting, and installing, and the reduction of plant mass takes some of the biological stress off of the stake when installed. Over 40 bundles were collected over 2 days with the ZooTeens and 23 bundles were collected by the workshop attendees.

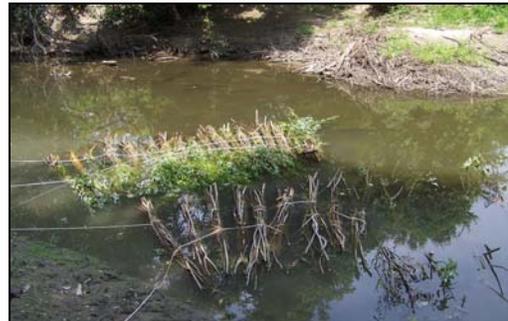
Live stakes were soaked to promote growth.

Immediately after each of the two harvesting events in mid-August, the bundles were taken to a secure stream location and soaked for two weeks. Hydrating the stakes helps to increase their chances of survival and rooting once installed on-site. The project was done in late August, a typical dry time of year, so it was important to do anything to help the stakes survive. The materials harvested by the workshop attendees were also soaked but for a less than one day, as they were installed fairly soon after harvesting. Initial results have been promising, but the next growing season will determine how many and which species showed the best survival.

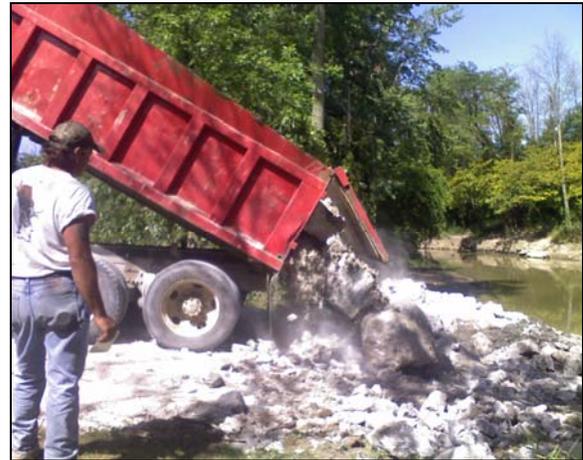
An early load of large stone being delivered.

stone will be trucked also needs to be considered as well, since most trucks have aluminum beds and cannot handle large stone. Trucks with steel bodied beds are needed to transport the large material.

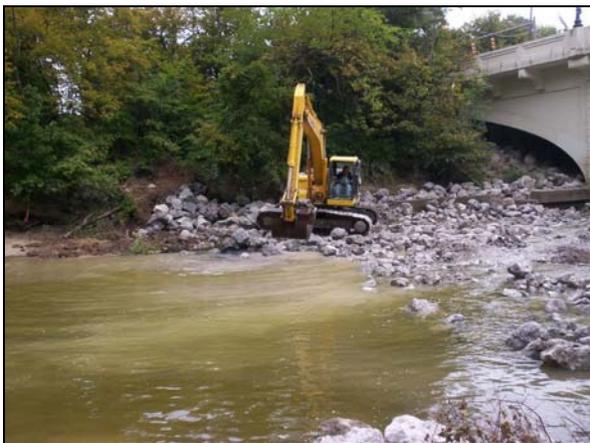
Heavy equipment was used to move the rock across the stream and to compact it.

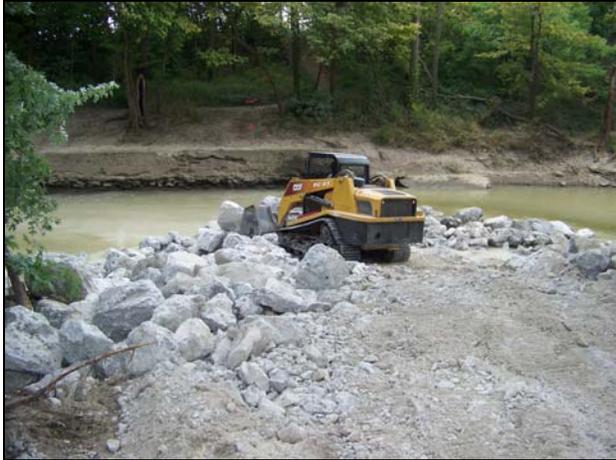
Rocks were dumped on the west bank and pushed across to form the second structure.

As more stone was delivered and dumped, the excavator worked from west to east distributing the stone to create the rock ramps. There is typically a bedding layer of smaller stone placed in the truck along with the armor stone to prevent punctures in the truck bed during loading and unloading. This bedding layer of unsorted smaller material was incorporated into the ramp as construction preceded helping to lock the material in place. The excavator worked to

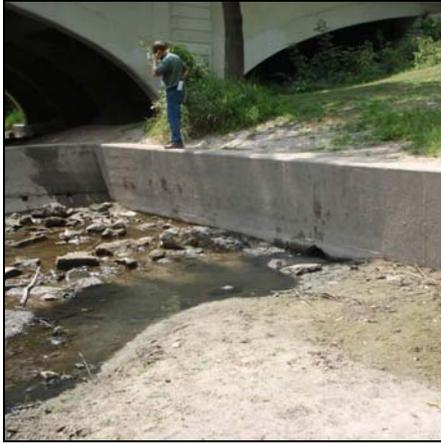
Unknown discharge entering Swan Creek through submerged storm pipe.

Another unplanned issue arose during the early stages of the in-stream construction. A submerged storm water outfall was located on the western retaining wall of the dam. This pipe was overlooked during design as it was partially blocked by a sediment bar that had formed in

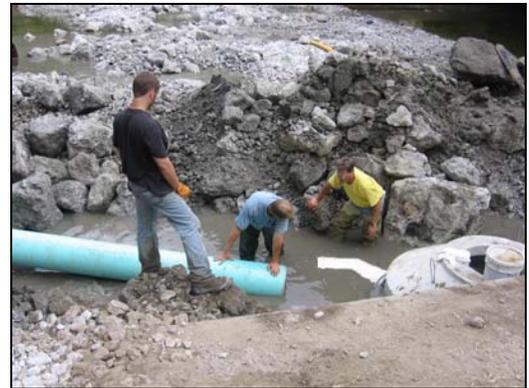
New manhole and storm sewer pipe being connected to an existing storm sewer in the dam's west retaining wall.

In order to avoid covering the storm water pipe outlet in the dam wing wall with the rock ramp, a manhole structure and pipe were connected to the outlet. A second pipe was extended from the manhole that would outlet to the stream. The rock ramp was then constructed around the manhole and over the pipe.

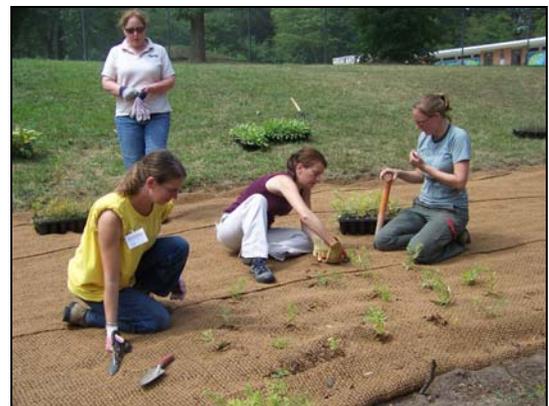
Native plant plugs being planted in the large native garden.

Approximately 10 cubic yards of compost was mixed into the top 6"-8" of soil to prepare the planting bed. Volunteers from the workshop spread mulch over the surface of the two planting gardens, and then laid erosion control blanket over the area, keying it into trenches on the perimeter of each garden. Over the course of two days, native plant plugs were installed through the blanket and were watered. After planting was finished, additional mulch was scattered over top of the erosion control blanket for improved aesthetics and to serve as a deterrent to keep vandals from seeing and therefore pulling the blanket up.

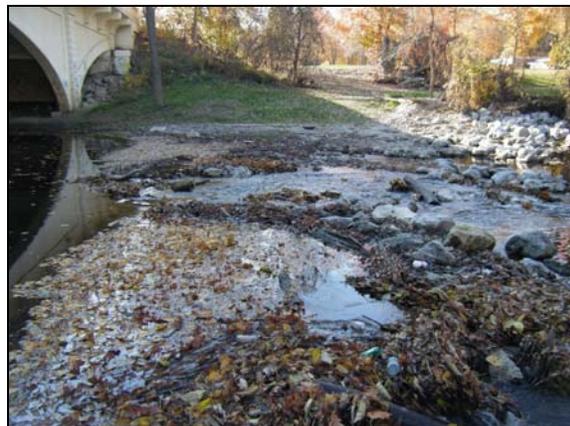
Wood, leaves, and debris caught in the upstream structure, but they did not affect the movement of water through the low flow channels.

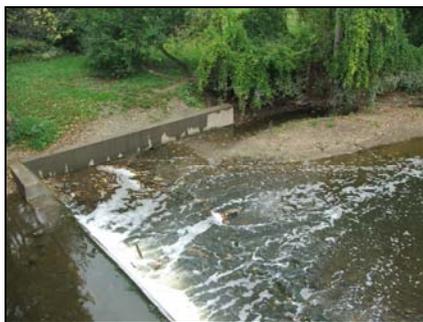
Pre-Construction (*low flow conditions*)

Upstream site looking west

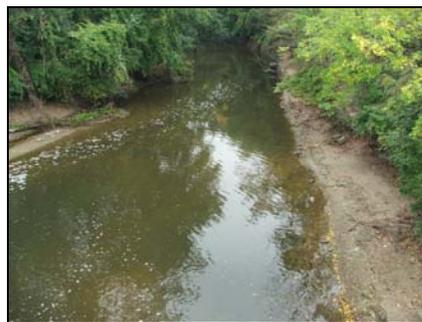
Downstream site from upstream

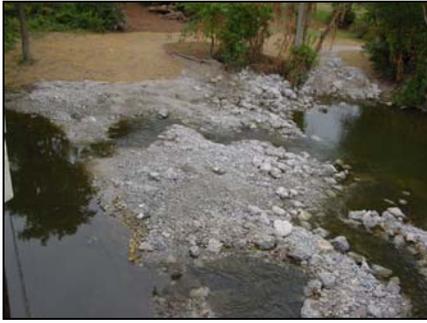
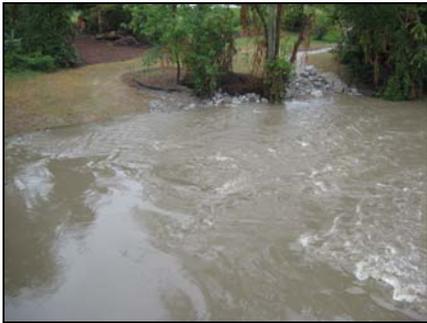
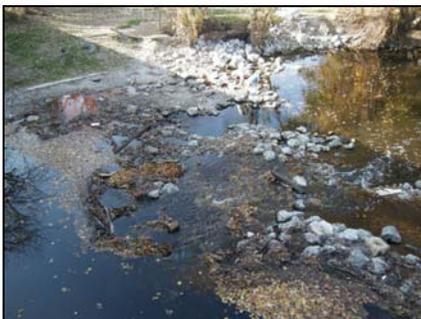
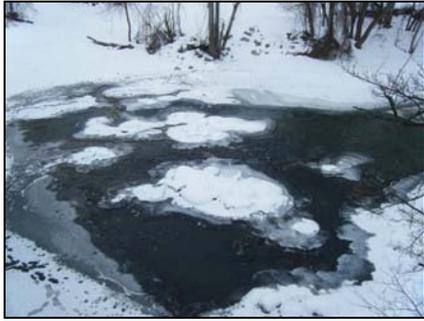
Upstream structure looking west

The early results of this project are very promising. As illustrated above, the structures have held up to flood conditions, woody debris and leaves, as well as snow and ice. The preliminary results from the live stakes are also looking good. Within two weeks there were stakes with new leaves on them. The local harvesting of plants and soaking

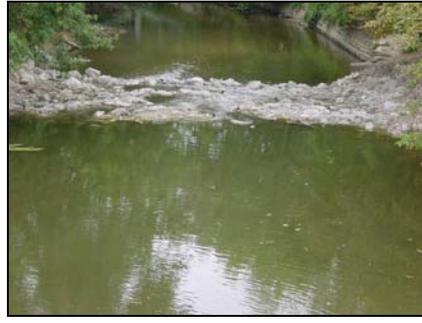
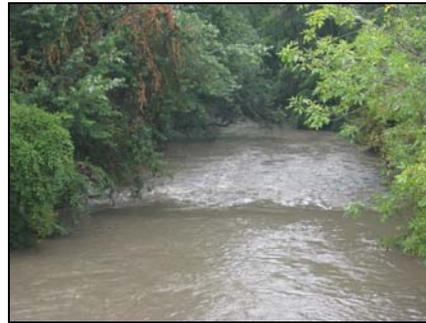
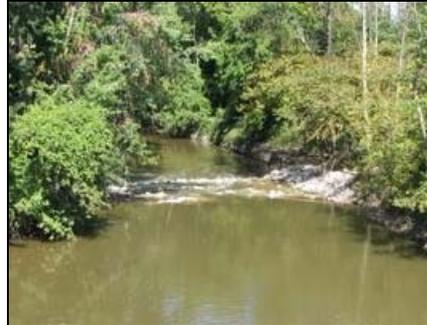
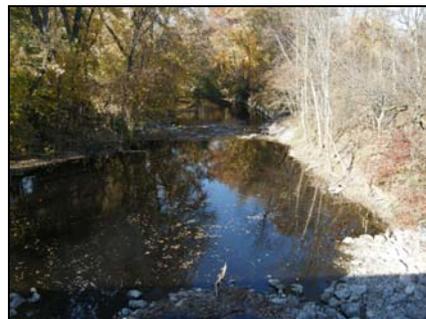
Downstream structure from upstream

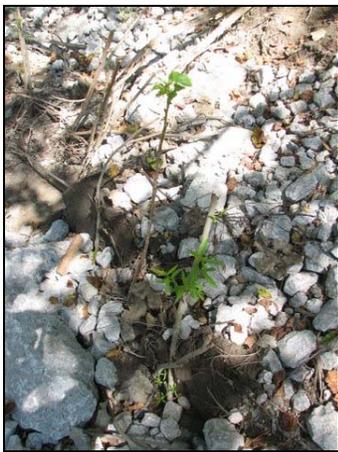
Willow stakes 2 weeks after planting.

to facilitate growth seems to have worked. We will need at least one growing season to see if the stakes have actually rooted and established themselves.

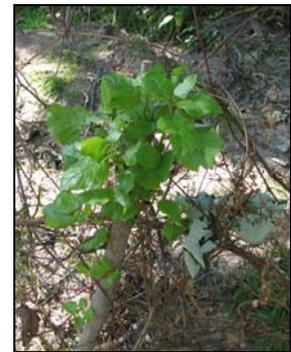
A cottonwood stake 2 weeks after planting.

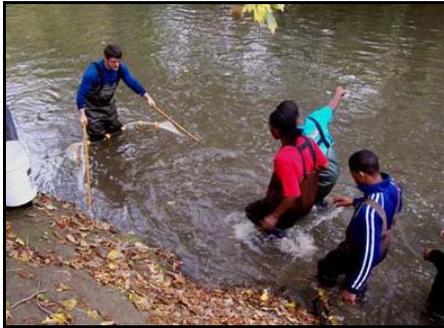
Students scuff the bottom to “kick-up” macro-invertebrates for collection.

The students measured the quality of water at each riffle in a series of physical and chemical tests, and sampled macroinvertebrates as a biological index. In the new upstream riffle they scuffed their feet upstream of a benthic seine for one minute and found two orders of macroinvertebrates. This gave them a Steam Quality Measurement (SQM) score of 4 (Poor). In the existing downstream riffle they repeated the method and found six orders of macroinvertebrates. This gave us an SQM score of 17 (Good).

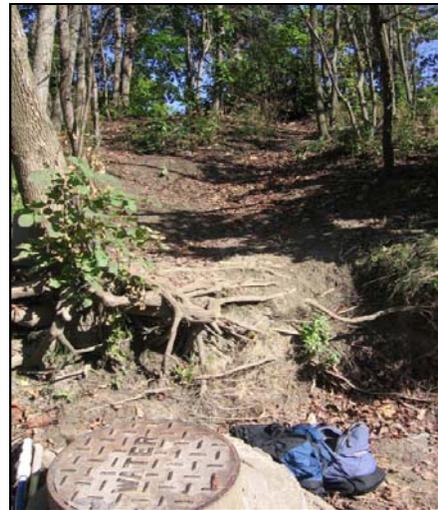
Possible site for access improvement project.
